THE MALDEN SURVEY

A REPORT ON THE CHURCH PLANTS OF
A TYPICAL CITY, SHOWING THE USE
OF THE INTERCHURCH WORLD MOVE-
MENT SCORE CARD AND STANDARDS
FOR RATING CITY CHURCH PLANTS

WALTER SCOTT ATHEARN

Copyright 1920 by the
Interchurch World Movement
of North America

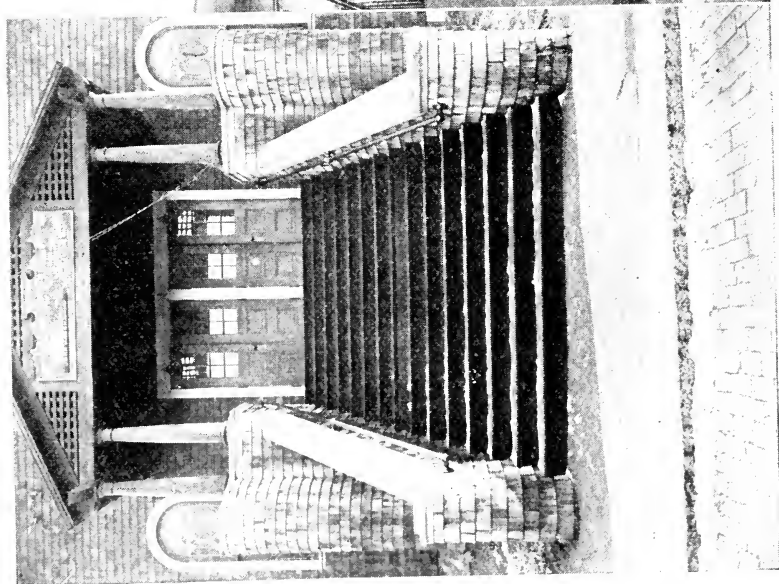
ILLUSTRATION 30. THE FIFTEEN TREAD STEEP FRONT STAIRWAY OF THE ROBINSON METHODIST CHURCH

The "second story" auditorium of the Robinson Methodist presents nearly equal possibilities for disaster. The exterior view of the Robinson Methodist in illustration 5, shows the steep ascent from the ground level to the first floor. A second steep broad stairway without adequate handrails runs from the first floor as shown in illustration 31, page 67, to the floor of the auditorium shown in illustration 29, page 66. The extreme width of this church auditorium would add to the danger in case of fire. The careless storage of old shingles and other materials in such a manner as to increase the fire danger was noticed in this basement.

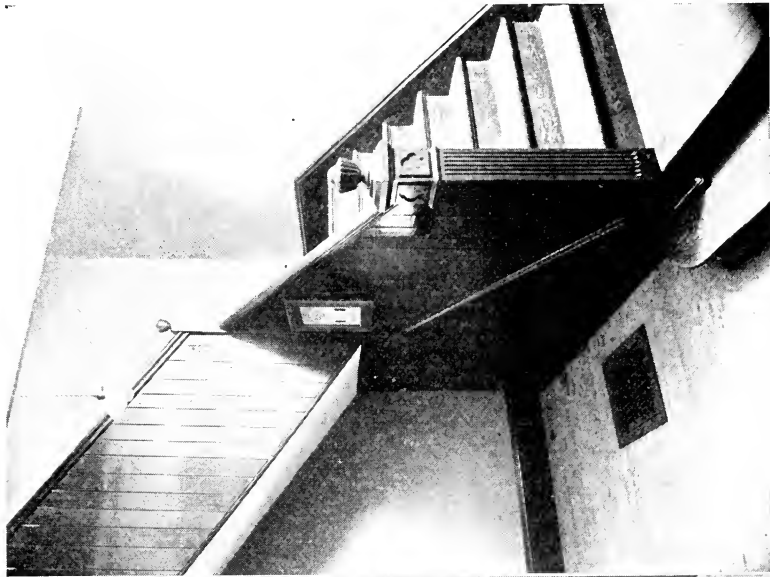
ILLUSTRATION 34. THE UNPROTECTED FRONT STAIRWAY LEADING FROM THE AUDITORIUM SHOWN ON OPPOSITE PAGE

Illustration 34, page 71, reproduces the single main stairway which is used for exit from the auditorium of the Maplewood Methodist Church (see illustration 32, page 70). The secondary stairway to the rear of this auditorium is not superior to the type shown in illustration 36, page 74. This main stairway is of wood, lacks handrails has three turns and is inadequately provided with artificial light.

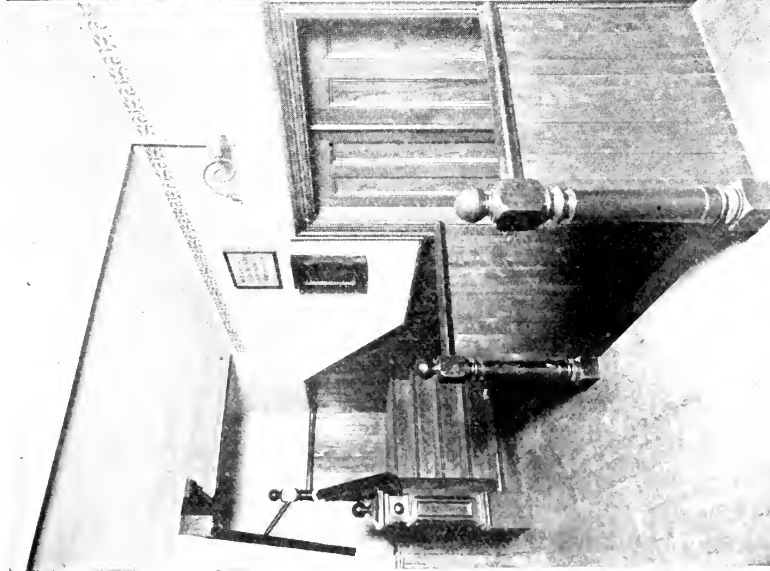
ILLUSTRATION 33. ONE OF TWO VERY POORLY CONCEIVED STAIRWAYS TO THE MAIN AUDITORIUM OF THE LINDEN CONGREGATIONAL CHURCH

Illustration 33, page 71, presents the highly unsatisfactory stairways of the Linden Congregational Church. Each of two stairways to the auditorium on the second floor is so narrow as to be easily congested and has three flights, with two turns. At the foot of the bottom flight, the passageway is partially blocked by the guards to the stairway entrance of the school assembly room on the first floor. Illustration 35, page 72, shows this entrance into the assembly room with the main entrance doors beyond. Since the auxiliary stairway to the rear of this building is entirely inadequate, it is difficult to conceive of a situation which presents greater hazards.

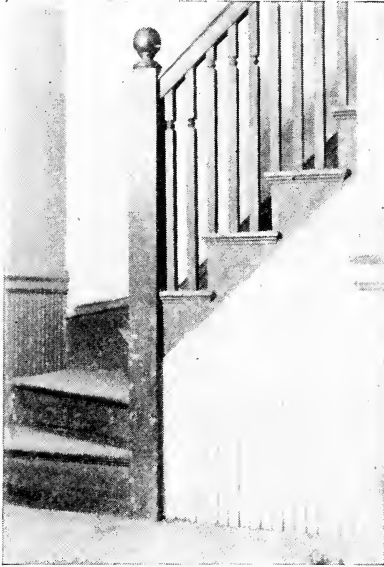
ILLUSTRATION 36. SEE TEXT ON THIS PAGE

Illustration 36, on this page, shows the only stairway leading from the church auditorium floor to the large assembly room of the basement of the Faulkner Methodist. This stairway is steep, lacks a handrail and has the faulty triangular treads.

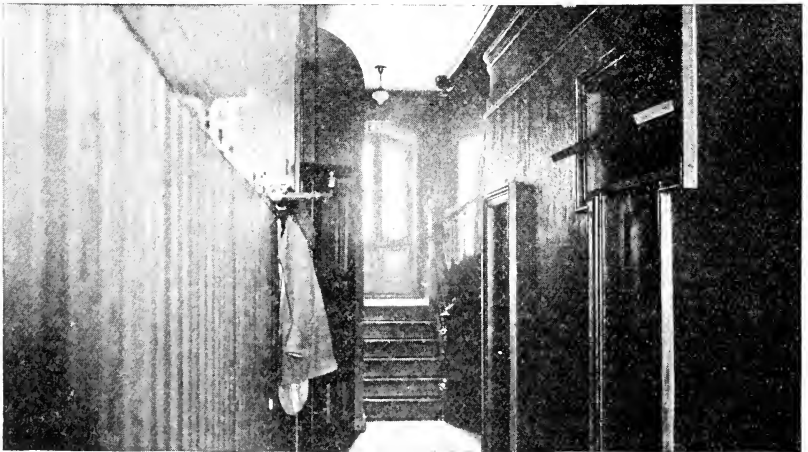
ILLUSTRATION 37. SHOWING THE APPROACH FROM CHURCH AUDITORIUM TO THE SCHOOL ASSEMBLY ROOM OF THE FIRST CONGREGATIONAL CHURCH

The two winding stairways of the First Congregational Church, of which one is shown in illustration 37, page 74, are very defective types of communication between the two main floors of a church structure.

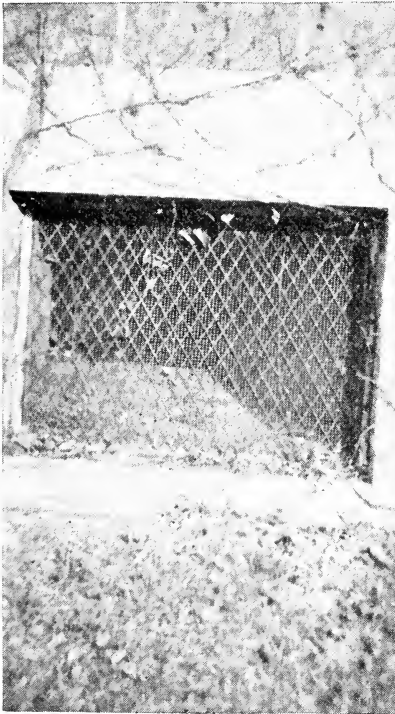
ILLUSTRATION 47. AIR INTAKE OF THE UNIVERSALIST CHURCH, LOCATED AT GROUND LEVEL

Illustrations 47, 48 and 49, pages 90 and 91, point out the prevailing arrangement for securing fresh air in the churches which have made provisions for fresh air supply. Such intakes, even though screened, cannot be as desirable as those located sufficiently high above ground level, and cannot prevent the entry of small dirt particles or dust and filth blown directly from sidewalk or alley. Air drawn from ground levels should be filtered or washed. All heated air should be properly humidified before entering large audience rooms. These provisions are expensive and yet are found possible in large plants. It should be borne in mind that a hot, dry air may be the cause of colds and sore throats for a surprisingly large proportion of an audience.

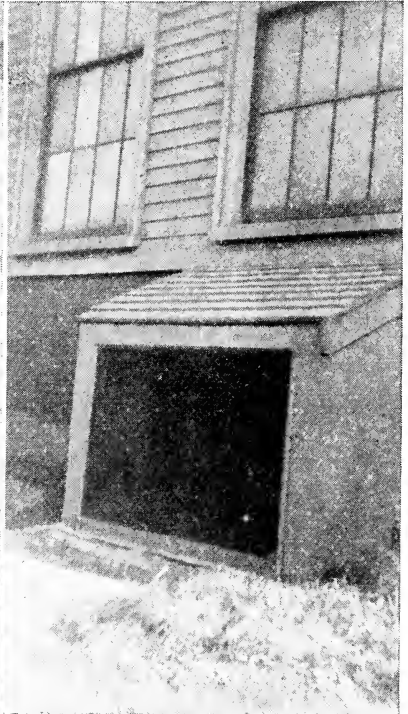
ILLUSTRATION 48. AIR INTAKE OF THE FIRST CONGREGATIONAL CHURCH LOCATED AT GROUND LEVEL

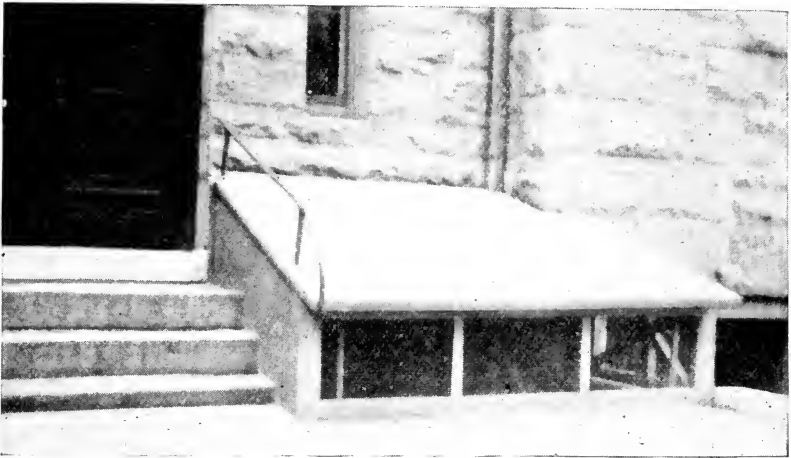
ILLUSTRATION 49. GROUND LEVEL AIR INTAKE OF THE FIRST BAPTIST CHURCH. IT SEEMS UNWISE TO TAKE AIR FROM DUST COVERED WALKS EVEN THOUGH IT IS WASHED BEFORE BEING SENT INTO THE ROOMS ABOVE

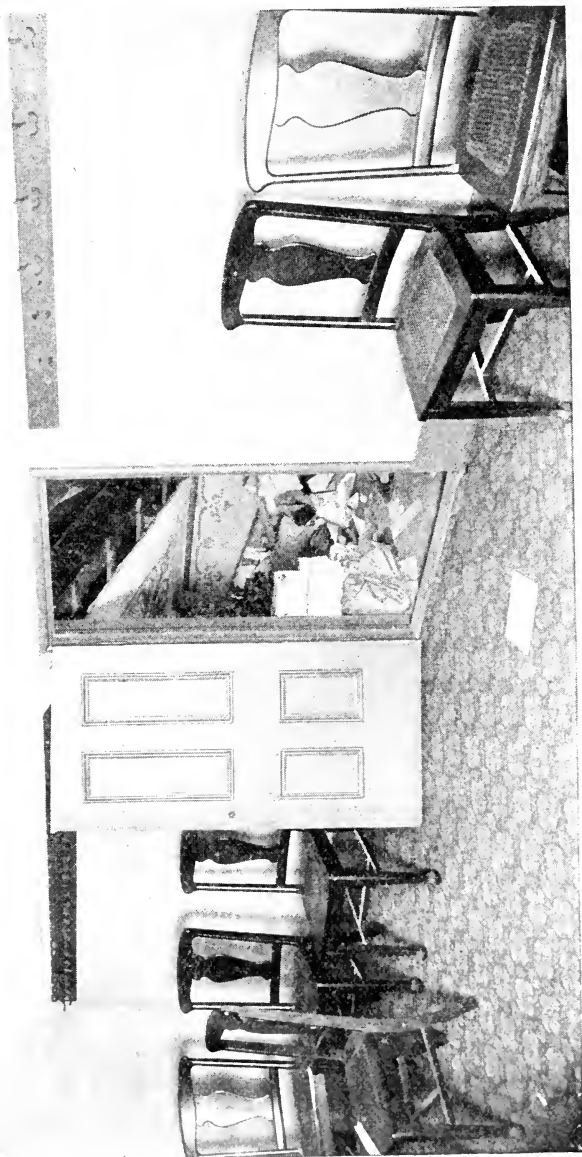
ILLUSTRATION 54. EVIDENCE OF EXTREME DISREGARD OF FIRE DANGERS IN A STORE ROOM DIRECTLY UNDER THE RAFTERS OF THE MAPLEWOOD BAPTIST CHURCH. MUCH EASILY COMBUSTIBLE MATERIAL HAD BEEN TOSSED INTO THIS STORE ROOM

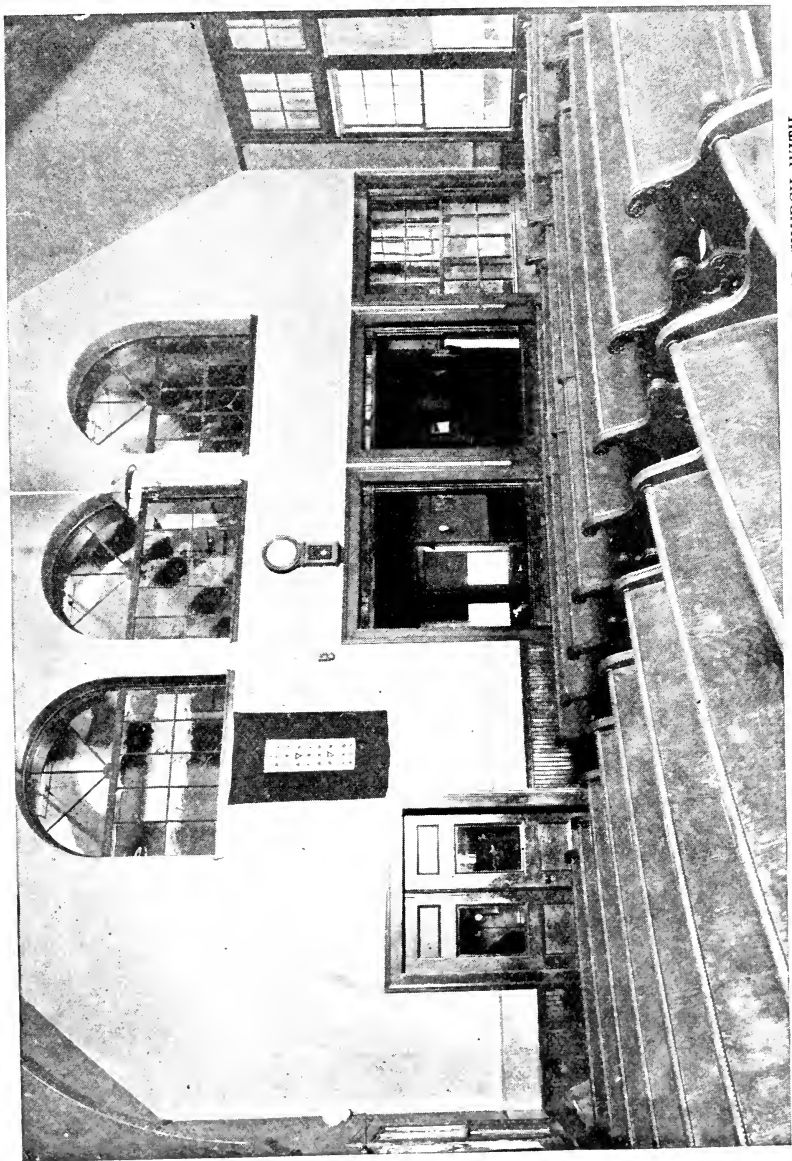
ILLUSTRATION 62. THE AUDITORIUM OF THE MYSTIC SIDE CONGREGATIONAL CHURCH WITH CLASS ROOMS TO THE REAR. WINDOWS IN ROOM ARE RAISED AND CLASS ROOMS USED TO SUPPLEMENT THE AUDITORIUM

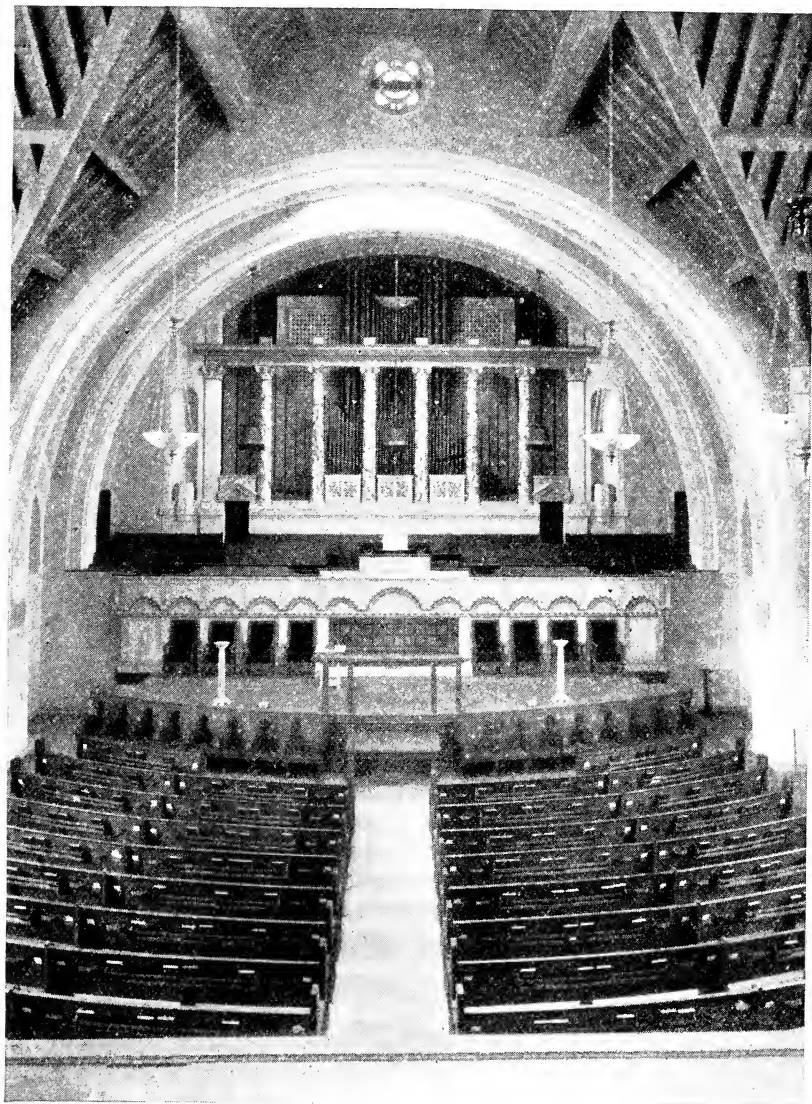
ILLUSTRATION 64. THE WELL-LIGHTED, ATTRACTIVELY DECORATED AND PLEASINGLY PLANNED AUDITORIUM OF THE FIRST BAPTIST CHURCH

This item was provided for in varying degrees of adequacy, but in most cases sufficient provision was made for the needs of the church. In the Eastern Avenue Baptist Church and the People's Church of the Nazarene, there was inadequate provision for dressing rooms and for seclusion in entering and leaving the baptistry. The most adequate provision for this rite is made in the memorial baptistry of the First Baptist Church, shown in illustration 64, page 120.

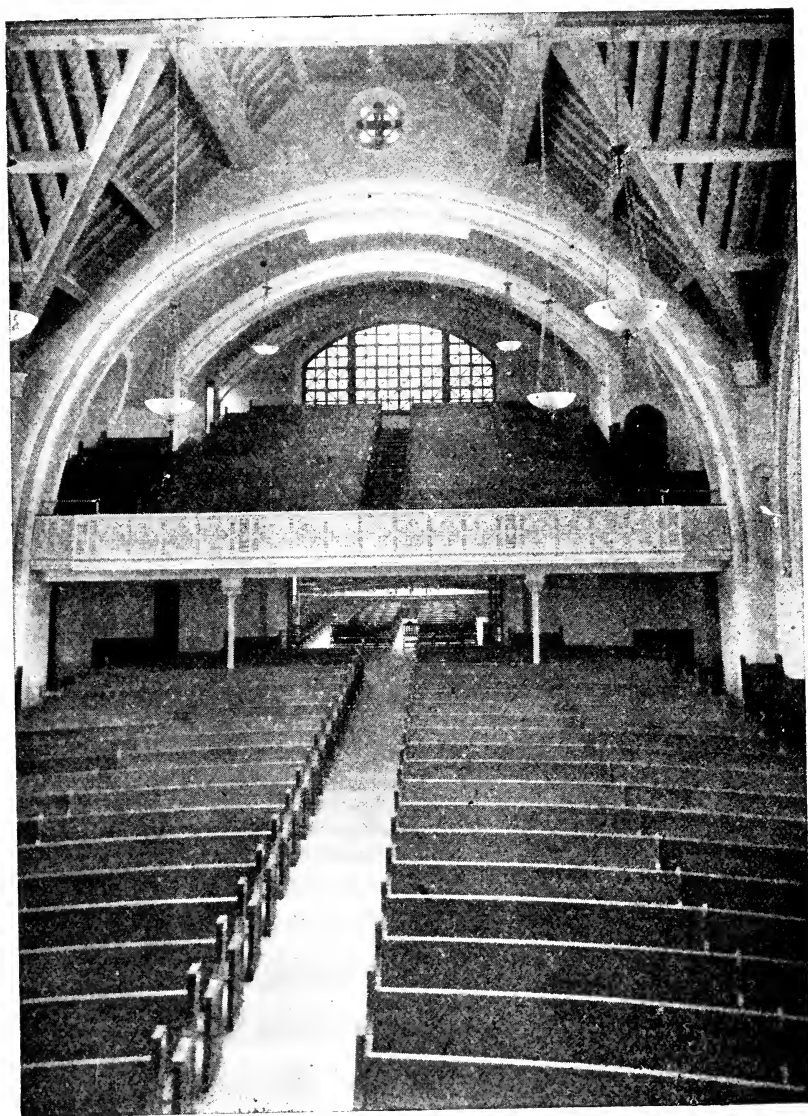
ILLUSTRATION 65. SHOWING THE BALCONY AND DESIRABLE CONNECTION BETWEEN AUDITORIUM AND CHAPEL. FIRST BAPTIST CHURCH

A church auditorium seating less than three hundred people should not have a balcony. Unless the room seats over four hundred, the balcony should be located at the rear of the room. The balcony of the First Baptist Church is inadequate, and it has the disadvantage

of being reached by winding stairways. With the present arrangement, people seated in the upper seats of the balcony face an annoying glare from the auditorium lights. The relation of balcony to auditorium is shown in illustration 65, page 121. The balconies of the Centre Methodist, illustration 53, page 97, and the Maplewood Methodist, are the only two to be given the total possible five points. Several of the churches have small balconies, inaccessible and with poor seating arrangements. One or two show by the conditions of the seats that they are not used.

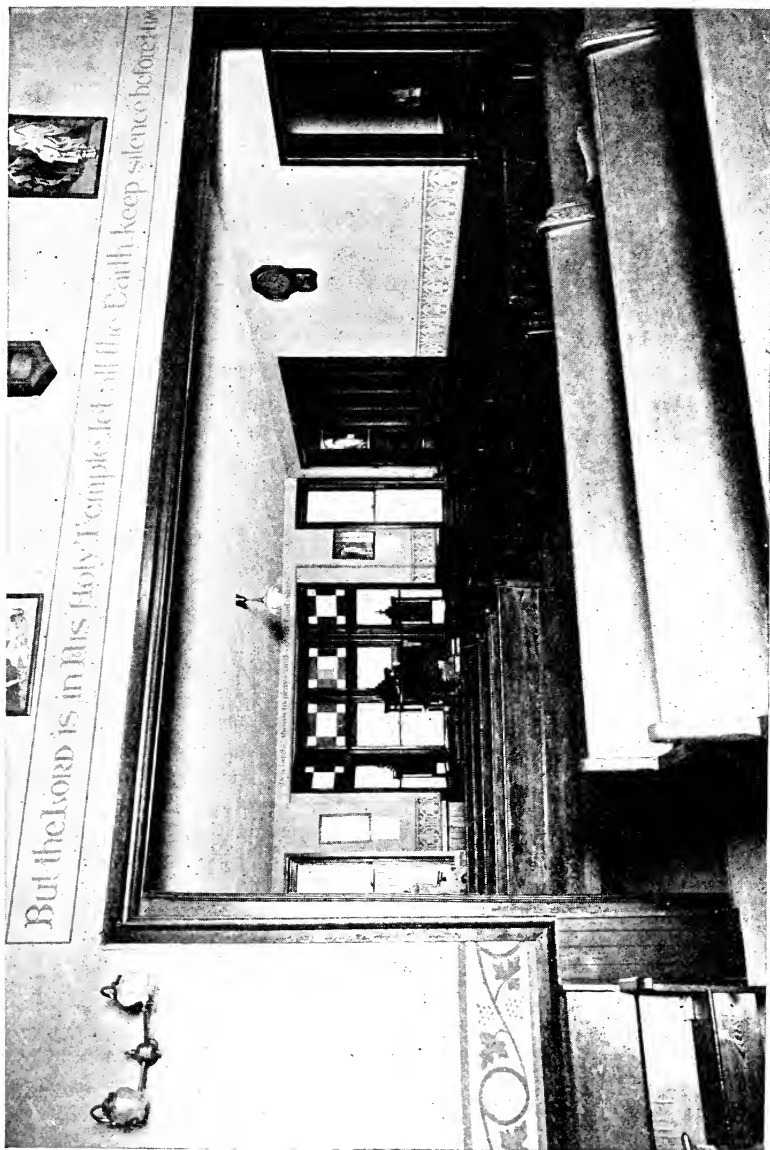
ILLUSTRATION 67. SHOWING CHAPEL OR SMALL ASSEMBLY ROOM OF EASTERN AVENUE BAPTIST CHURCH. NOTE CONVENIENT ARRANGEMENT OF ROOMS. LADIES' PARLOR, PASTOR'S STUDY, LIBRARY, CHURCH OFFICE ALL OPEN INTO THIS ROOM. PLACING OF SEATS MAKE AUDIENCE FACE COLORED WINDOWS

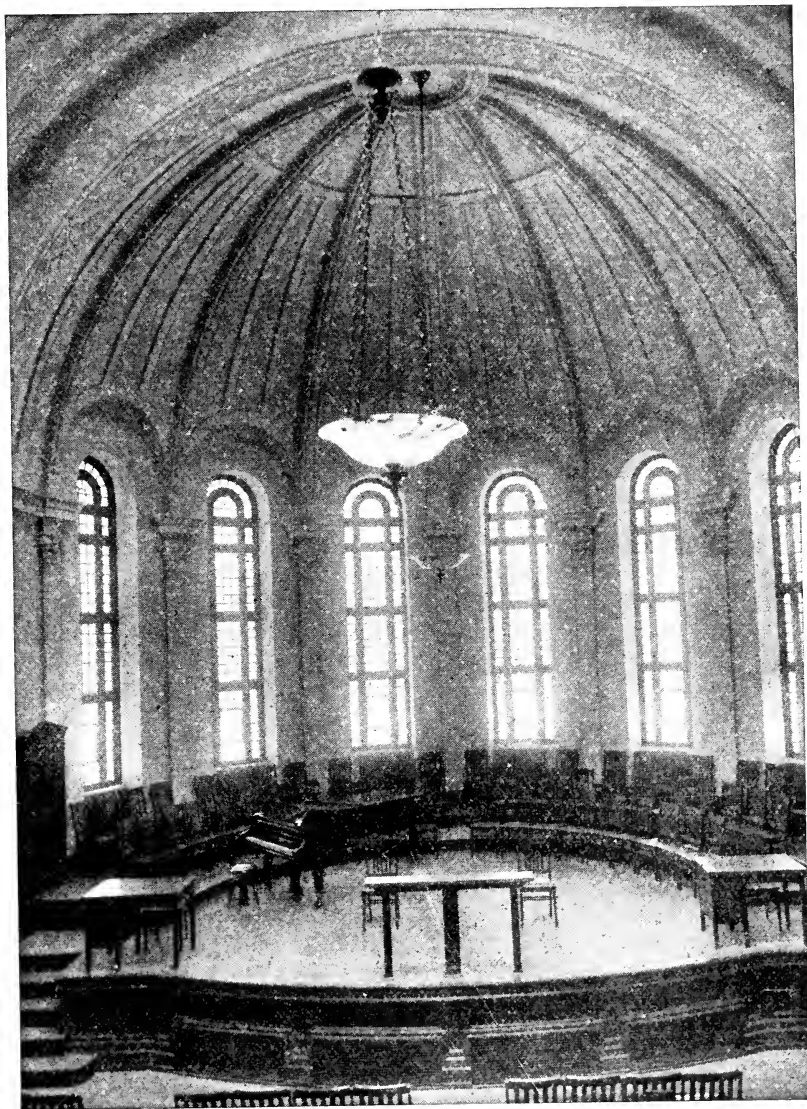
ILLUSTRATION 68. A SUNDAY SCHOOL ASSEMBLY ROOM IN THE FIRST BAPTIST CHURCH. WELL EQUIPPED PLATFORM, AND ATTRACTIVE ROOM, BUT AN ANNOYING SERIES OF CROSS LIGHTS FOR AUDIENCE TO FACE

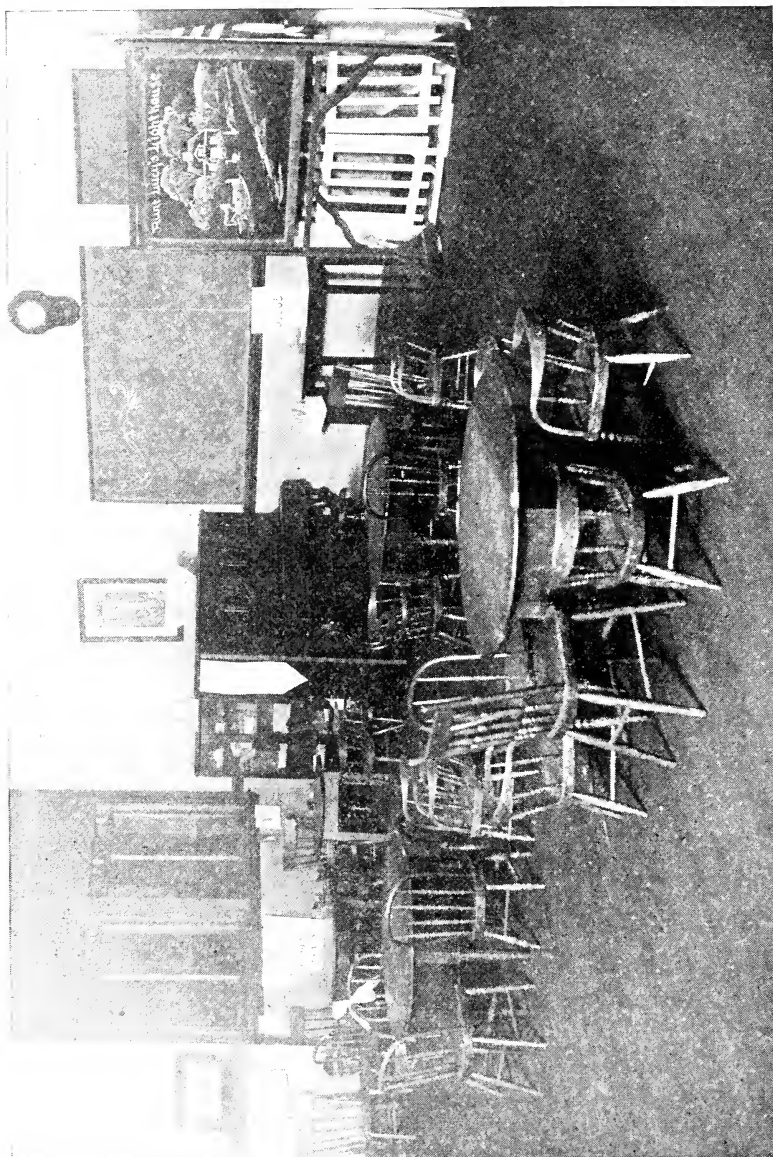
ILLUSTRATION 70. BEGINNERS' CLASS ROOM, CENTRE METHODIST CHURCH. A WELL EQUIPPED CLASS ROOM WITH MANY EVIDENCES OF GOOD TEACHING AND MODERN METHODS. IT IS UNFORTUNATE THAT THIS CLASS ROOM IS LOCATED ON THE SECOND FLOOR

the beginners' and primary department rooms the table-circles shown in illustration 70, afford all the segregation needed for that small part of the hour that is devoted to class work and the telling of the lesson stories. A wide floor that can be cleared quickly for room activities is relatively of far greater importance. This picture from Centre Methodist illustrates some of the furnishings of a good beginners' room, as currently advocated.

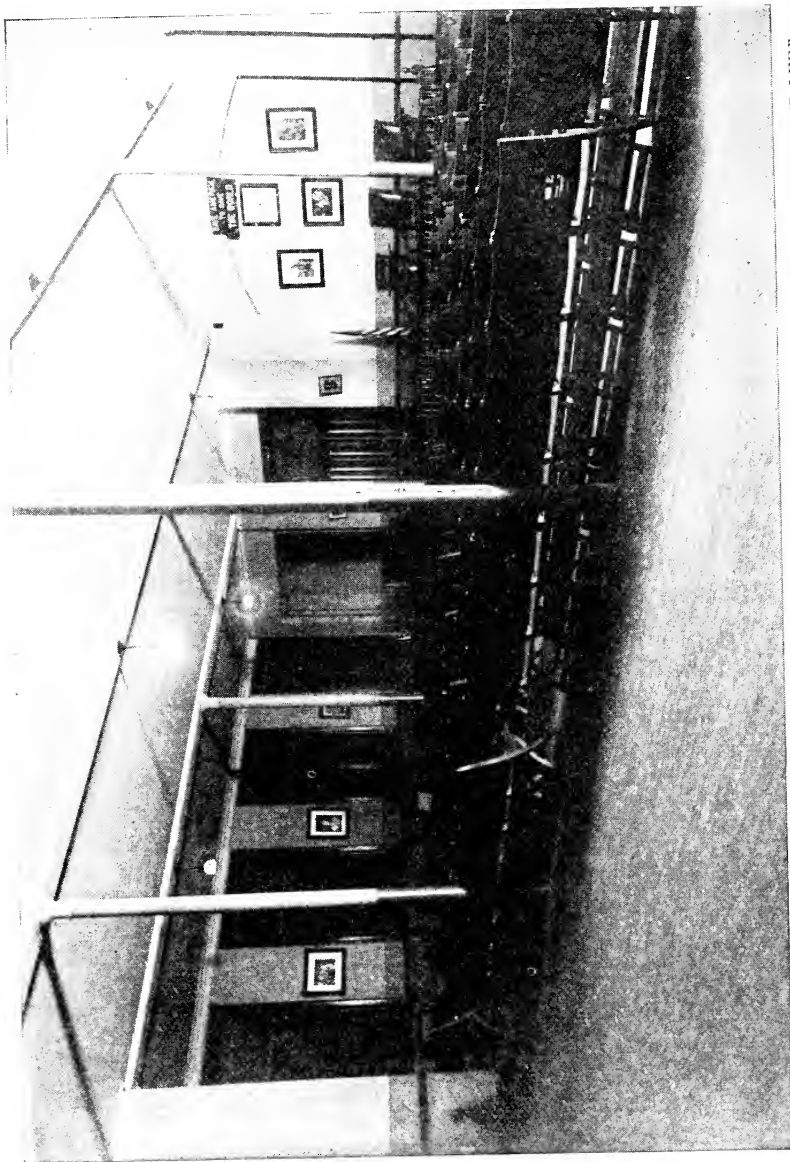
ILLUSTRATION 72. SUNDAY SCHOOL ASSEMBLY ROOM CENTRE METHODIST CHURCH. AT THE RIGHT AND LEFT OF THIS ROOM CLASSES ARE ASSEMBLED ON CHAIRS ABOUT TABLES WITH LITTLE OTHER EQUIPMENT.

The high standards for platform and stage have not been approached. These standards suggest a utilization of the school assembly for pageantry, dramatization and other school and community activities which cannot become possible because of the inadequate provision of the majority of assemblies in the seventeen plants. The highest scores on this item were allotted the First Parish in Malden, Universalist, and the First Baptist plants. These platforms may be seen in illustrations 73 and, 82 pages 141 and 153. The inadequacies of even these situations may be seen by a careful perusal of the standards on pages 197 to 199. The total inadequacy of the "Platform and Stage" of other plants is quite apparent in illustrations 71, 72, 51, pages 137, 139, and 94.

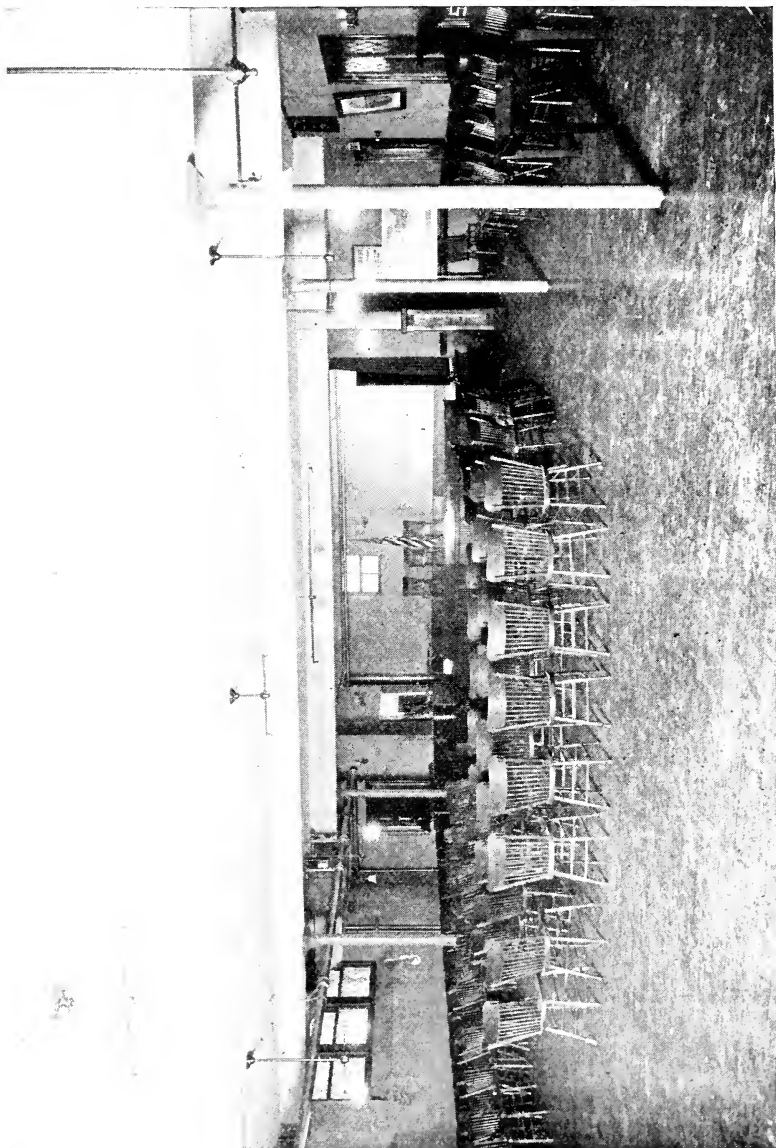
ILLUSTRATION 73. COMMUNITY ROOM OF FIRST PARISH IN MALDEN, UNIVERSALIST CHURCH. A BASEMENT ROOM WITH INSUFFICIENT NATURAL LIGHT. HAS PLATFORM STAGE WHICH CAN BE USED FOR SCHOOL AND COMMUNITY ENTERTAINMENTS

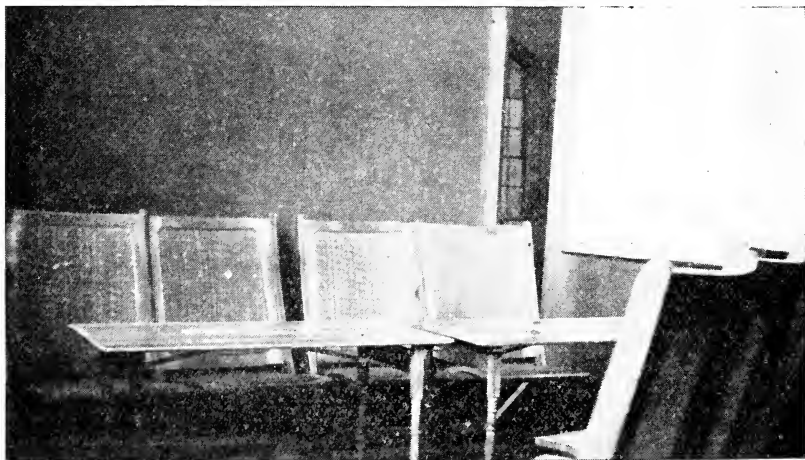
ILLUSTRATION 74. ONE OF SEPARATE CLASS ROOMS MADE BY SCREENS AT THE SIDES OF THE SUNDAY SCHOOL ASSEMBLY OF THE FIRST CONGREGATIONAL CHURCH

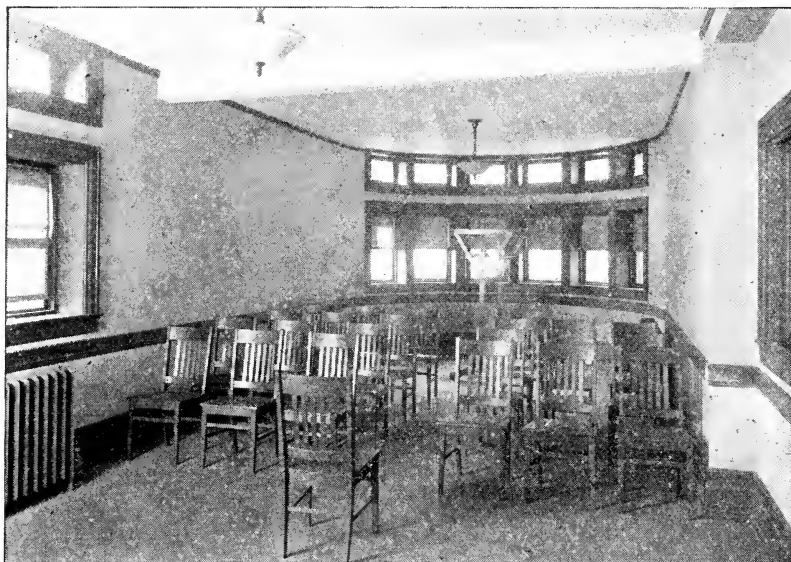
ILLUSTRATION 76. CLASS ROOM OF THE FIRST BAPTIST CHURCH,
EQUIPPED ONLY WITH CHAIRS AND COAT RACKS

A standard class room has doors swinging either outward or having a two-way swing. Even in the most modern plants in Malden this highly desirable standard is not followed. Class rooms should have built-in closets or cases for the storage of books and supplies and where a class room has no built-in closet, a neat cabinet for books, supplies and class exhibits would seem to be indispensable; even in the class rooms like those of illustrations 76 and 70, pages 144 and 132, inadequate provision is made in this matter.

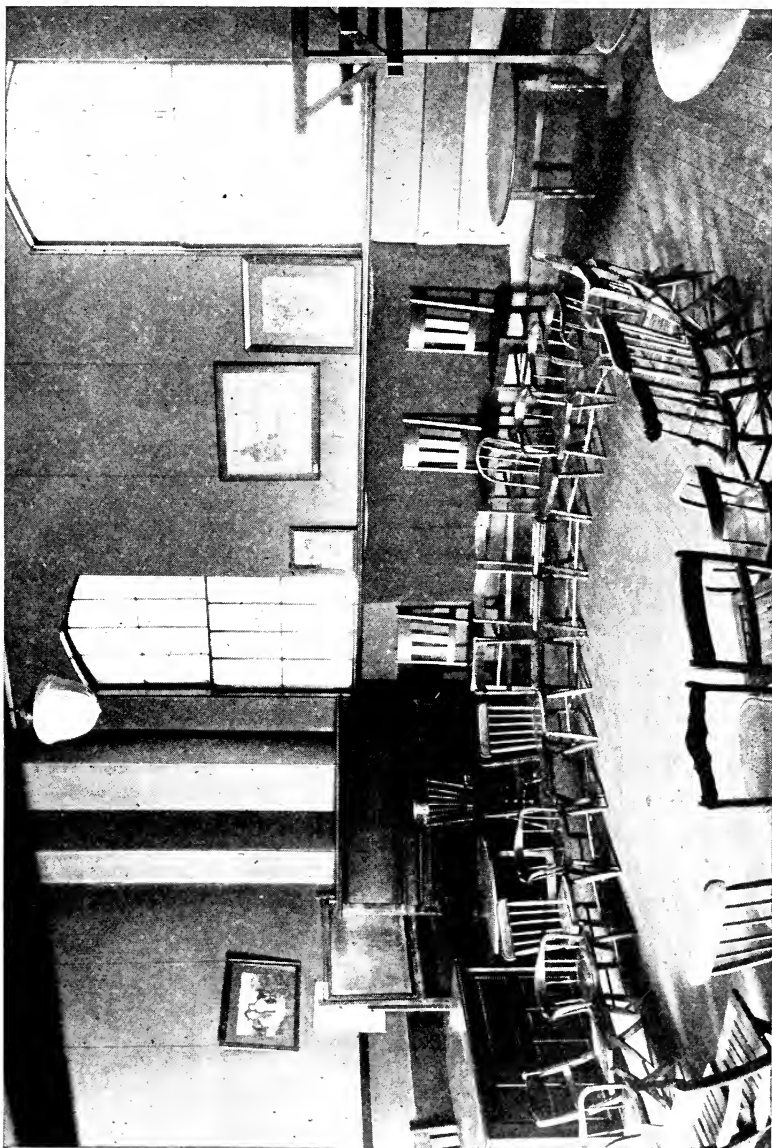
How a well-equipped primary room may be ruined by poor lighting is well shown in the two pictures of the First Congregational Church, illustrations 77 and 21, pages 145 and 57. Viewed by the photographer's flash, the room seems nearly ideal. But through those large windows almost no light comes except at certain times of day; and the second picture shows why. The shadow of the adjoining house falls on the windows like a black curtain, making artificial light a necessity. The church has wisely made this light as soft and pervasive as possible.

ILLUSTRATION 77. PRIMARY CLASS ROOM, FIRST CONGREGATIONAL CHURCH. A WELL ARRANGED AND WELL EQUIPPED ROOM. GOOD ARTIFICIAL LIGHTS OVERCOME THE POOR LIGHT CAUSED BY ADJACENT BUILDINGS. SEE ILLUSTRATION 21, PAGE 57

Blackboards and bulletin boards for the easy mounting of pictures, exhibits and notices were conspicuously rare. In only a few class rooms was there more blackboard space that is furnished by one or two movable blackboards. The use of blackboards for instructional purposes, especially with the younger children, is entirely impossible. A bulletin board or other display surface where pictures or samples of the work of the children may be attractively shown is an easily obtainable and highly desirable asset to modern instruction, and yet it is found in but very few of the religious class rooms of the seventeen churches surveyed. Such a surface made from a strip of burlap is shown in illustration 77, page 145.

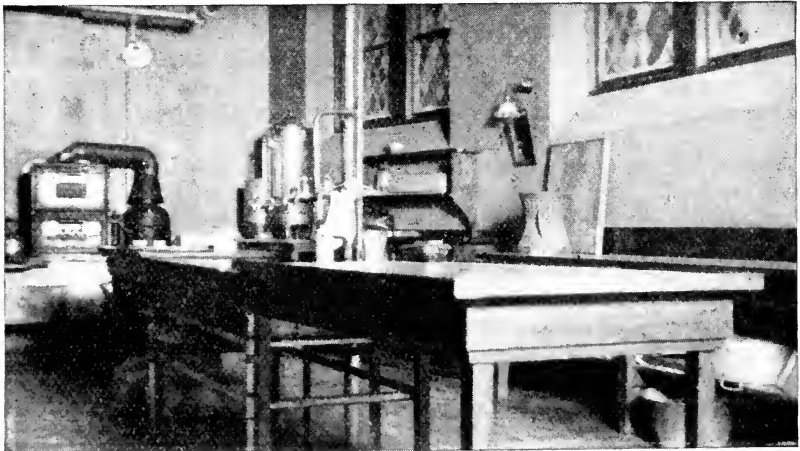
ILLUSTRATION 86. THE FAIRLY WELL EQUIPPED, WELL LIGHTED KITCHEN OF THE FIRST PARISH IN MALDEN, UNIVERSALIST
